GREAT NEAPOLITAN EARTHQUAKE OF 1857.

REPORT TO THE ROYAL SOCIETY OF LONDON
OF THE EXPEDITION MADE BY COMMAND OF THE SOCIETY INTO
THE INTERIOR OF THE KINGDOM OF NAPLES,

TO INVESTIGATE THE CIRCUMSTANCES OF THE GREAT
EARTHQUAKE OF DECEMBER 1857.

ROBERT MALLET, C.E., F.R.S., F.G.S., M.R.I.A.,
&c., &c.

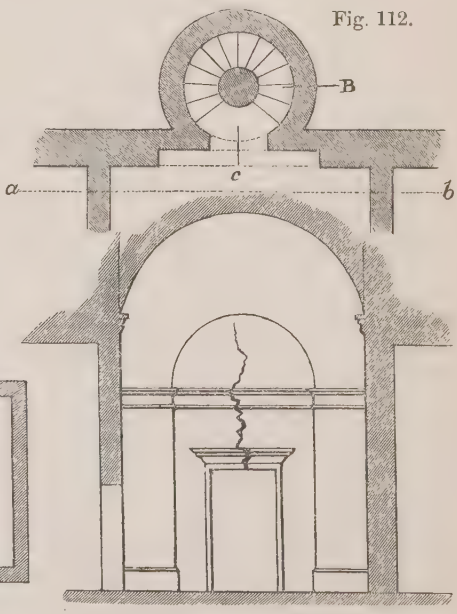
Fig. 113.

Fig. 113 is a section across the Salle Centrale at *a b* (Fig. 112), showing the interior elevation of the end next this tower. From the centre of the lintel of the doorway at *c*, a nearly vertical fissure, open 0·20 inch at bottom, extends upwards, becoming evanescent at about twelve feet, and its plane is in that of the meridian. Its continuation downwards can be traced from the centre of the sill of the doorway also.

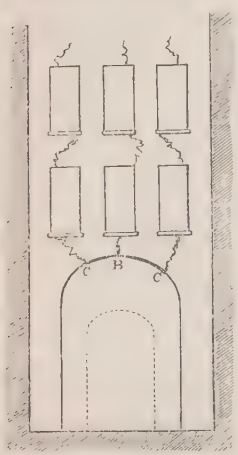
Fig. 14.

smaller arch as in dotted lines Fig. 114. The building, consisting of four lofty storeys, and nearly eighty feet in height, I found had been fissured from settlements for a length of time; but the shock had been sufficient to shake downwards the central mass of the wall between *c* and *c*, and to widen all the old fissures, which were now three-quarters of an inch wide—those *c* and *c* widest at top, B widest at bottom—evidencing clearly the nature of their production.

This, I found, was considered the most formidable example of injury to buildings occurring in or around Naples.

The derangement at the Palazzo Lieti was so considerable as to demand prompt measures to prevent the fall of one wall of the interior court, by building up solidly, a huge arched porte-cochère that had yawned beneath it, and was about twenty-four feet span, with a new wall and

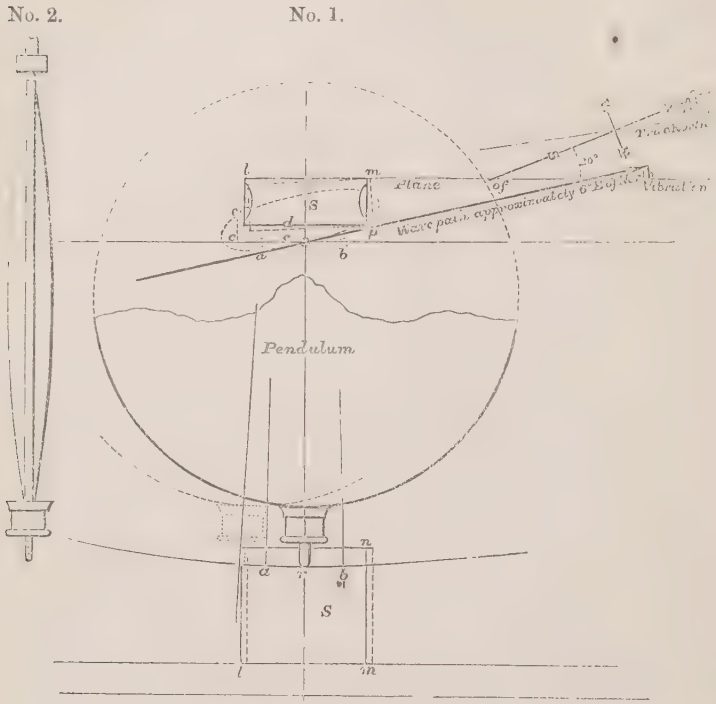
On the morning of the 17th December, 1857, Signor Fiodo found this clock stopped, and the screw of the pendulum in contact with the south end of the steel block,

which had been shifted from its place by the momentum of the pendulum, as in Fig. 115.

I shall recur to the inferences derivable from this in Part III. It is sufficient here to remark that the direction of wave movement indicated is one approximately 6° E. of N. The clock was going (tempo meridiano) or solar time for Naples, and was on the evening of the 16th December true to time within an error of 0·5 second. It had been stopped at 10^h 13′ 26″ P.M., which was therefore the time of the first shock at Naples, within less than half a second the error of the clock (slow), + the minute fraction of time due to the increased semi-arc of vibration.

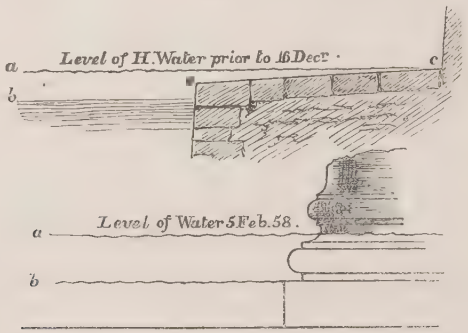
Fig. 117.

water which was then standing at *a* (Fig. 117), had, directly after the shock of December, fallen to *b*, equivalent to a rise of the temple of 7 inches, but that, since that time, the water had gradually returned to its former level, *i. e.* the land had sunk again.

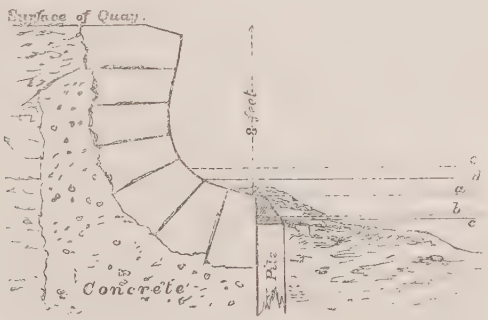
Fig. 118.

tide, he said, was always previously at *a* (Fig. 118), or coincident with the top of the timber work, at

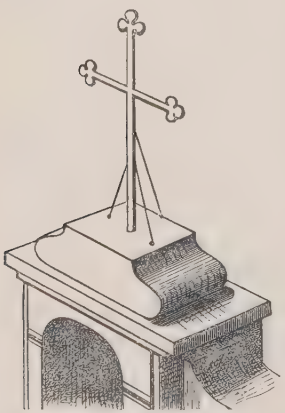
Fig. 122.

The direction I derive from them is 34° 30′ W. of N. There are upon various points of the cathedral and attached buildings many slender iron crosses, the iron flat bars of about $1\frac{1}{2}$ inch × $\frac{3}{8}$ inch thick, as in Fig. 122, none of which present any signs of having been bent or twisted. They were all confined, however, by small diagonal stays of round iron, about $\frac{1}{4}$ inch diameter. In the noble old cloister court, a long stone, part of the shaft of an old column that had leaned against a wall running nearly N. and S., was overthrown, and indicated a wave-path of about 60° W. of N.

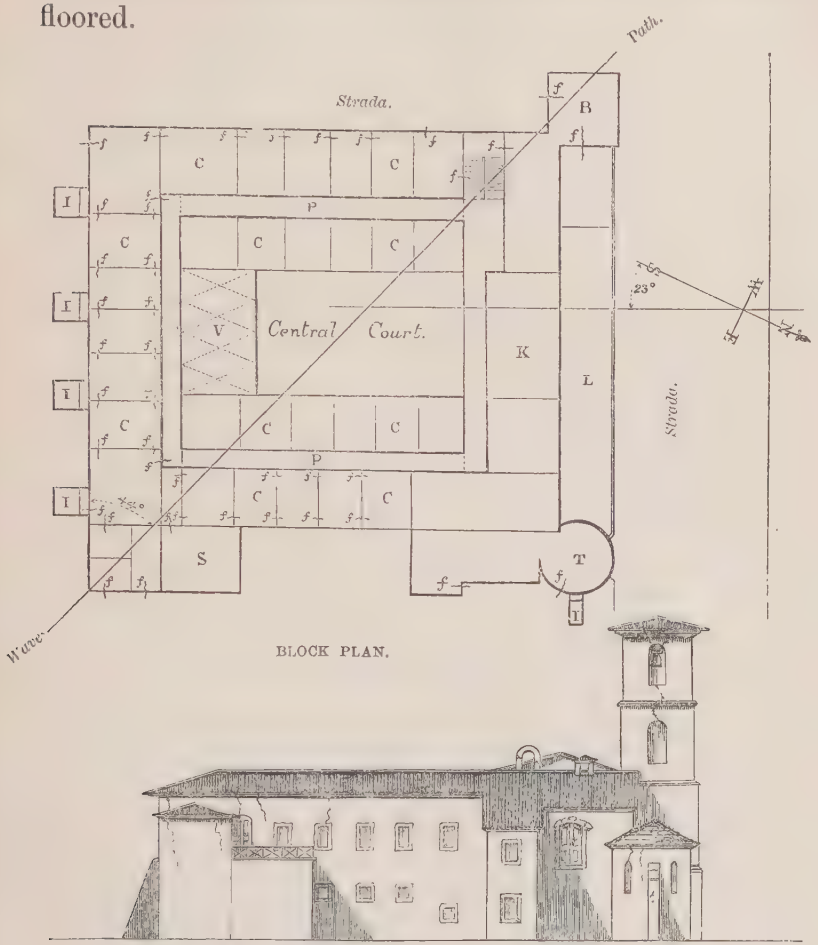
Fig. 127.

None of the photographs (Figs. 124, 125, 126, Coll. Roy. Soc.), were taken sufficiently near, unfortunately, to show with distinctness any external fissures in this building, nor to show the S. W. angle at all. Referring to the block plan and elevation (Fig. 127), however, some large fissures in the external walls of the projecting buildings over the terrace, and, generally, in that portion of the structure, give an angle of slope with the vertical = 15° to 16°, and allowing for the change due to the ordinal of the building, indicate an angle of emergence for the wave-path $e = 18°$ from the E.

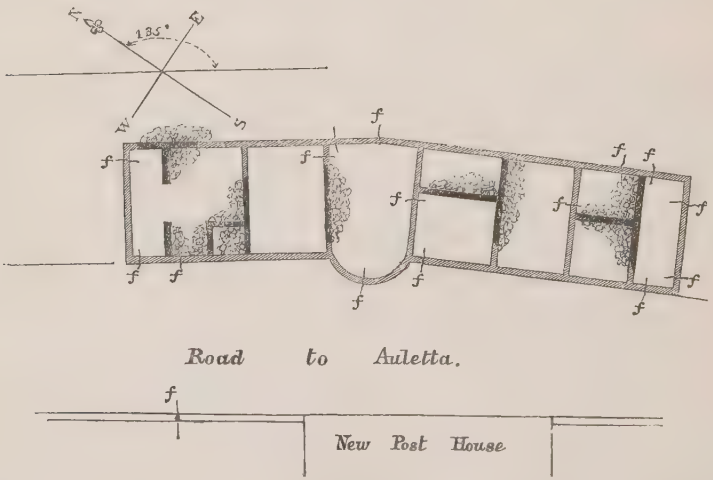
Fig. 128.

The place was damaged by the earthquake of 1783, and rendered uninhabitable by that of 1851. Its general length bears 135° E. of N. The fractures and fissures produced in December are clear and distinct from the old ones. In the sketch (Fig. 128), the portions coloured black indicate the

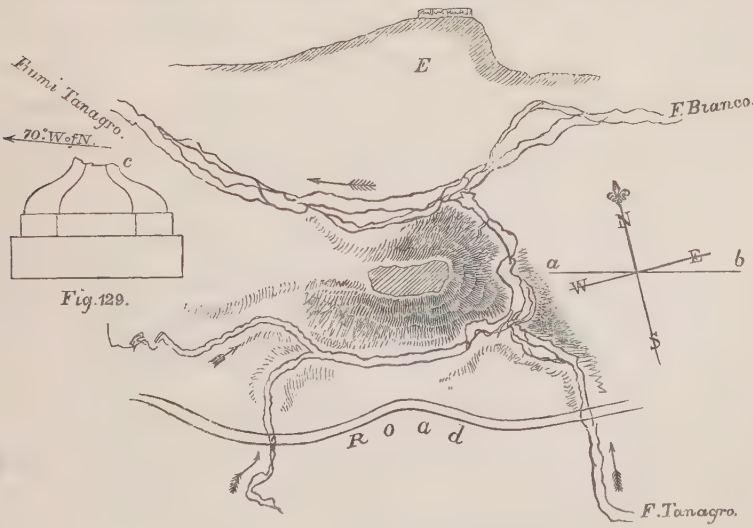
Fig. 130.

with its steep end towards the east, and buttressed away to the westward by a longer slope, as in the section E (Fig. 130) taken in a line with *a b*.

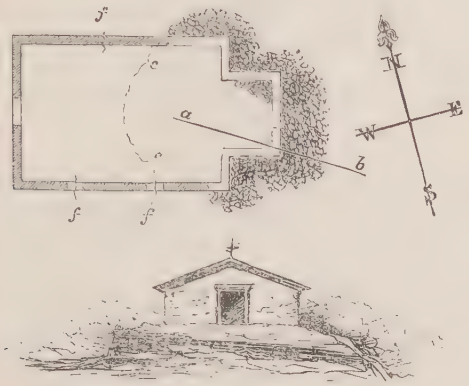
Fig. 131.

This church is a poor building, the walls about 15 feet high and $2\frac{1}{2}$ feet in thickness, of coarse limestone rubble, covered with a heavy tiled roof upon gross, ill-framed timber. The north wall had, in part, long leaned outwards (as I was informed by the priest), and a portion had fallen towards the north; but all the remainder of the east end had fallen outwards, or in a general direction of the line *a* to *b* (Fig. 131), and a much larger portion of the roof, as indicated by the irregular line *c c*, had come down and fallen within the walls. In both the north and south walls were some fissures *f f f*, which, together with the general direction in which the mass of dislodged material had been thrown, indicated a wave-path of from 80° 30′ W. of N. to nearly due W. and E. The mode in which the roof

had come down, seemed to indicate a considerable amount of emergence in the wave-path, from the eastward, but

how much, neither it, nor the direction of the fissures, in the coarse rubble, and through the heads of the windows, would indicate.

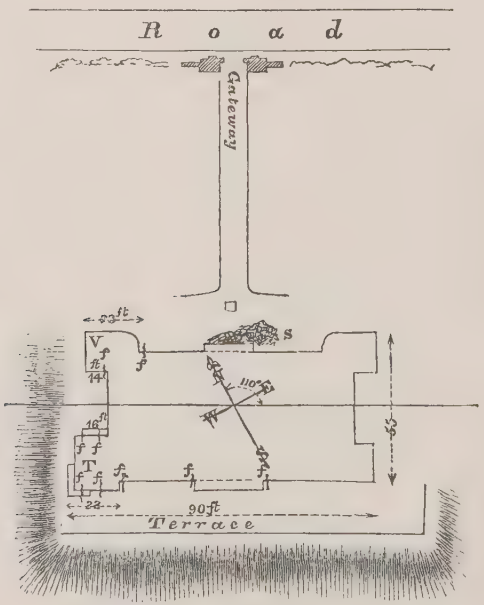
Fig. 139.

The only fissures are those marked *f f*, &c., in the west end, all in the ancient towers, and two fractures in the slender brickwork of the southern arcades. The towers have been thrown westward, off from the body of the building, and the fissures at the rëenterant quoins are $2\frac{1}{2}$ inches open at top, and run nearly from top to bottom of the walls, which are about 32 feet in height to the eaves, and the whole of the west end is out of plumb. The fissures in the south front are seen in Photog. No. 137. Their direction has been determined and limited at the quoin, by the form of the buttress built into it, for nearly

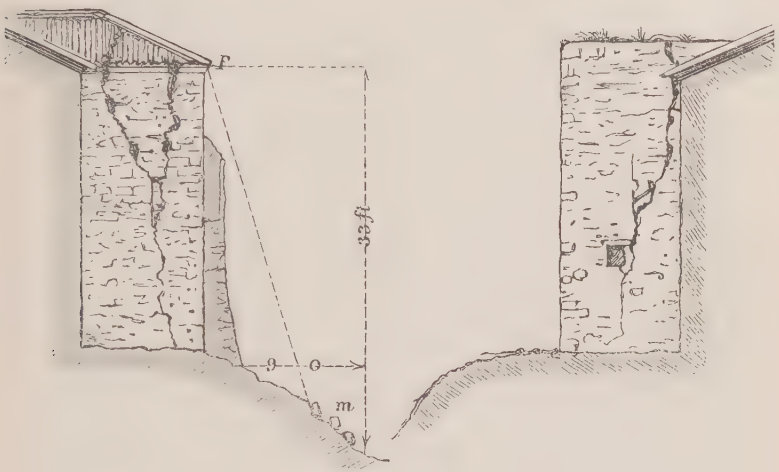
Fig. 140. Fig. 141.

The fissures at the internal flanks of the tower, that, T, (ground plan, Fig. 139), looking south, and that, V, looking north, are pretty exactly sketched in Figs. 140 and 141.

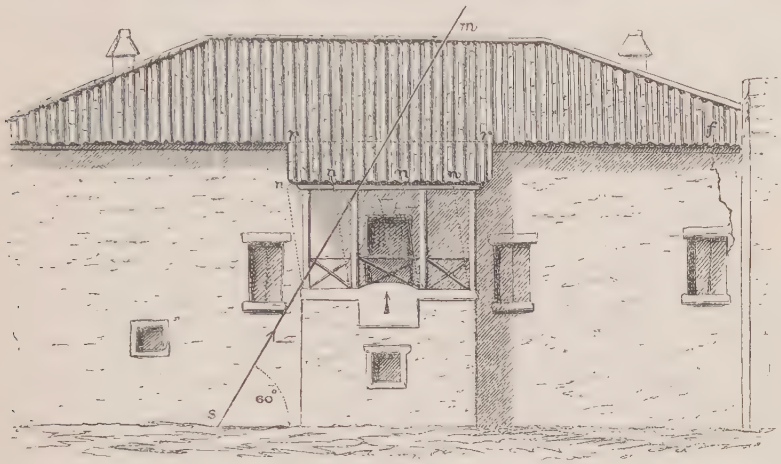
Fig. 142.

(which corresponds to that above the "Portone" of the south front) stood, before the earthquake, a wooden sort of verandah, framed, as shown in Fig. 142, and covered by a

prolongation of the slope of tiling of the roof. The whole of this had been thrown down, and was lying on the ground at and about the point *s* (in Figs. 139, 142, and Photog. No. 138) in dislocated fragments, from which, collecting and laying together the timber-work, I was able to reconstruct the design of the fabric.

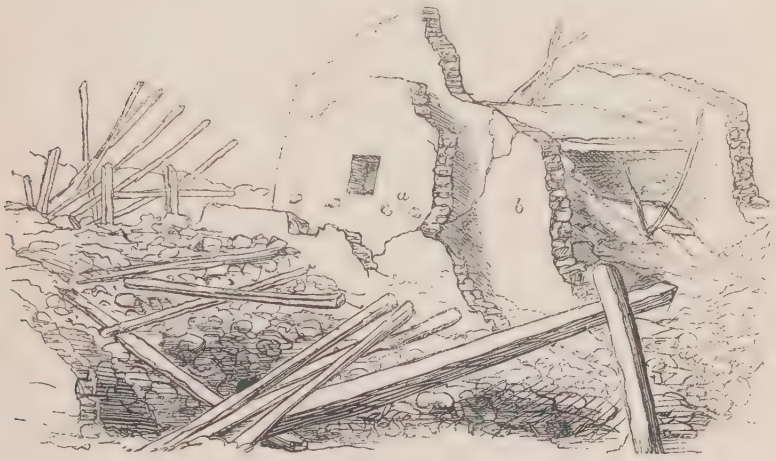
Fig. 152.

a certain range nearly cardinal. The walls *a* and *b*, and all parallel to them, run nearly E. and W. These were in great part, more or less standing, but fissured, in sloping cracks; but the walls whose plane had been N. and S.

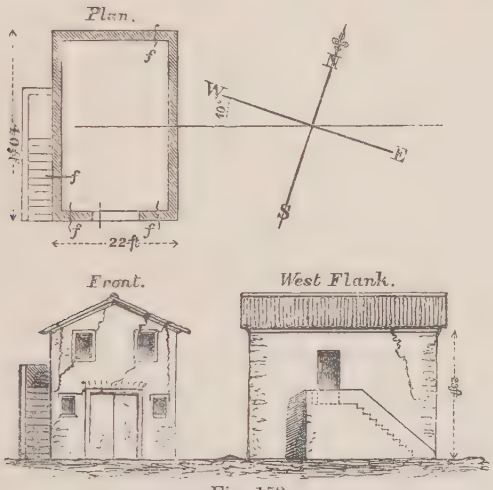
Fig. 153.

cardinal (axial line 10° W. of N.), built of good rubble, with cut stone jamb dressings, and middling quoin stones, and with a heavy external stone staircase on the west flank. It was fissured in several places, and the fractures gave a wave-path of 120° W. of N., and an emergence of about 65° with the horizon. The emergence might be steeper, however, as the direction of the fissures in the front, had been coerced in some degree, by the large proportionate surface, of cut stone jamb dressings.

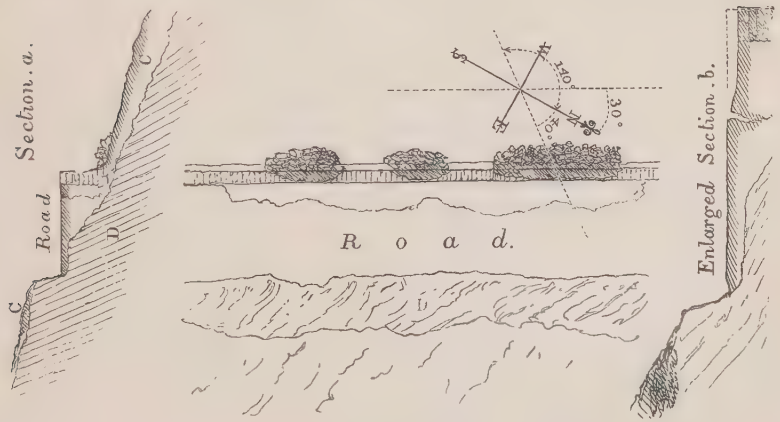
Fig. 157.

At the former point nearly, the road is formed upon a side cutting and small embankment, on limestone covered with 3 or 4 feet average, of arable clay land. It is sustained by an ill-built revetment wall of dry stone, with mortared top courses, in all about 12 feet high. The general direction of the centre line of the road is 30° W. of N., and nearly level. For a length of about 300 yards, an irregular longitudinal fissure was open, in the surface of the roadway, at about a quarter of its breadth from the revetment wall, of about 3 to 4 inches in width, and in some spots still, 10 or 12 inches deep, though much obliterated and filled by rain washings.

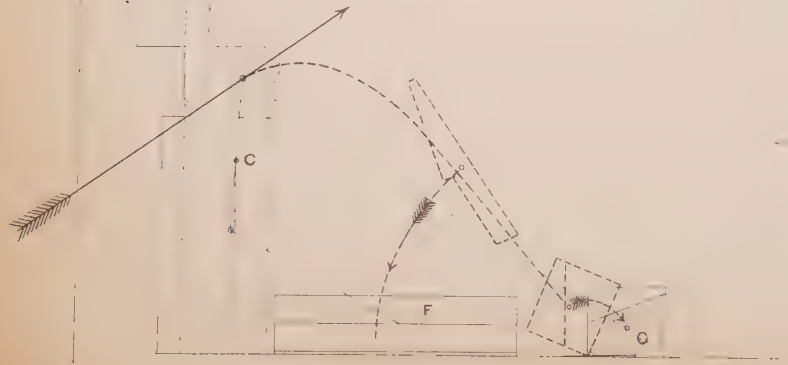
STONE BLOCKS OF THE CAMINE IN KITCHEN AT PALAZZO PALMIERI. THROWN FORWARD.

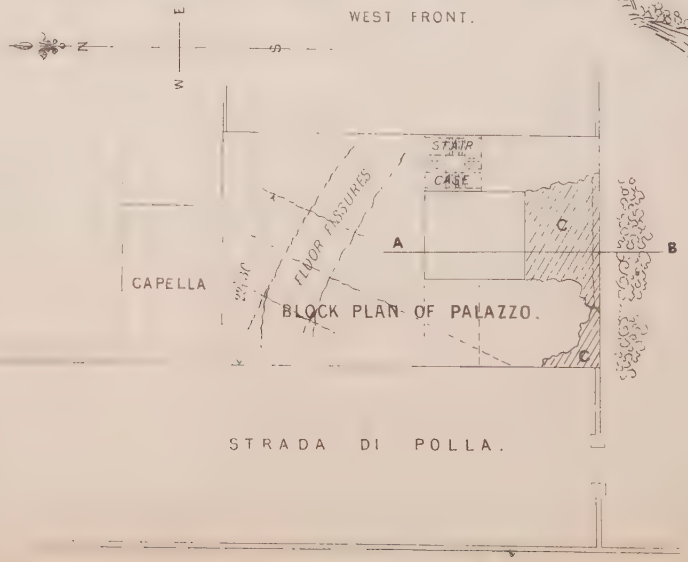
C. C. PART PROSTRATED THROWN SOUTH.

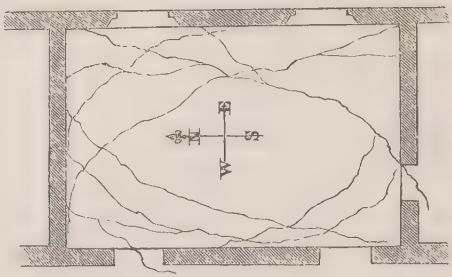
Throughout the Palazzo, the floors are of beton and tiles, laid upon thick oak planking, crossing over oak and fir joists at about three feet apart: some in the largest rooms at the north wing, have been brought down altogether, the fractured beams showing, that they yielded to the inertia of the mass of beton and tiles, under the emergent wave. All are fissured, in various directions diagonally across, the lines more or less curved, with the *hollow sides of the curves towards the centre* of the floor, and upon the whole making angles of about $22^\circ\ 30'$ with their respective walls, and crossing each other towards the mid length, nearly at right angles; the great prevailing direction $22^\circ\ 30'$ E. of north, and at right angles to the same. These floor fissures, as nearly as they could be drawn by the eye,

in one of the large reception rooms of the first floor, are shown in Fig. 181.

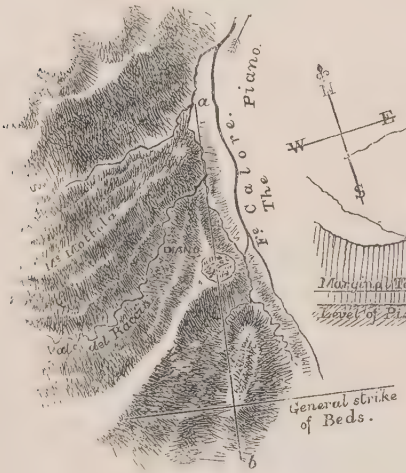
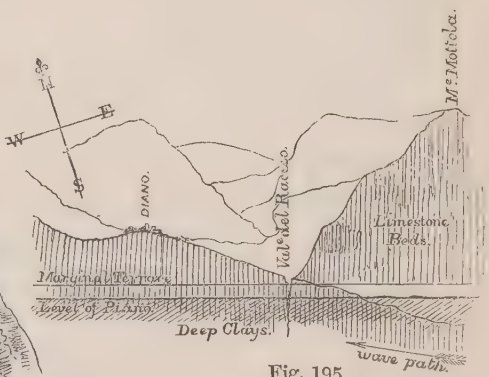
The comparative immunity from destruction of Diano, is not difficult to explain. The direction of wave-path was here nearly due north to south. It therefore passed from the deep clays of the piano into the long spur or colline of the town, end on, (see Sketch Nos. 194, 195,) losing a large portion of

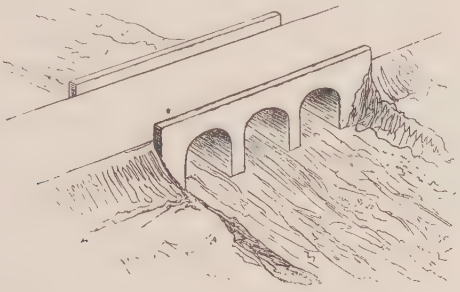
Fig. 196.

The structure was not overloaded with material and was well put together, and the mortar still green. It did not exhibit a trace of injury. (See Fig. 196.)

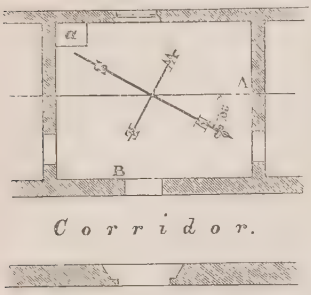
Fig. 200.

A number of glazed lithographs, in flat wood frames, each hung from a single nail, upon the north and east walls of

the room, A and B (Fig. 200). Within a second or two after the chocolatière had begun to jump and make a noise, the lithographs hanging upon the wall A, began to oscillate slightly in the plane of the wall, or from east to west, and the reverse; and at the same instant, those hanging upon the wall B, began to oscillate slightly, out from and back to that wall, *i. e.*, in the same east to west direction. The great shock now arrived, and the frames upon the wall B, at once began to sway forward and back in the plane of the wall, or in a direction south to north, and the reverse; while those upon the wall A, commenced the movement out from and back to the wall; and for a moment or two he thought they all moved more or less both ways, viz., in the planes and at right angles to the planes, of both the east and west and north and south walls. The motion ended finally, by the prints on the wall B, alone oscillating gently in its plane, with a decreasing motion, for two or three seconds, and finally coming to rest.

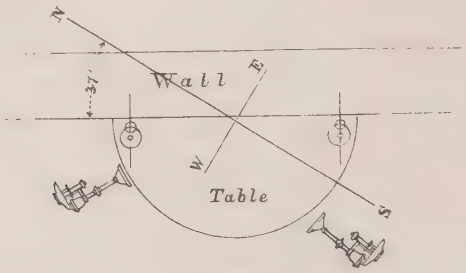
Fig. 204.

normal to the face of the wall, the position of the lamps indicates a wave-path, about 157° W. of north.

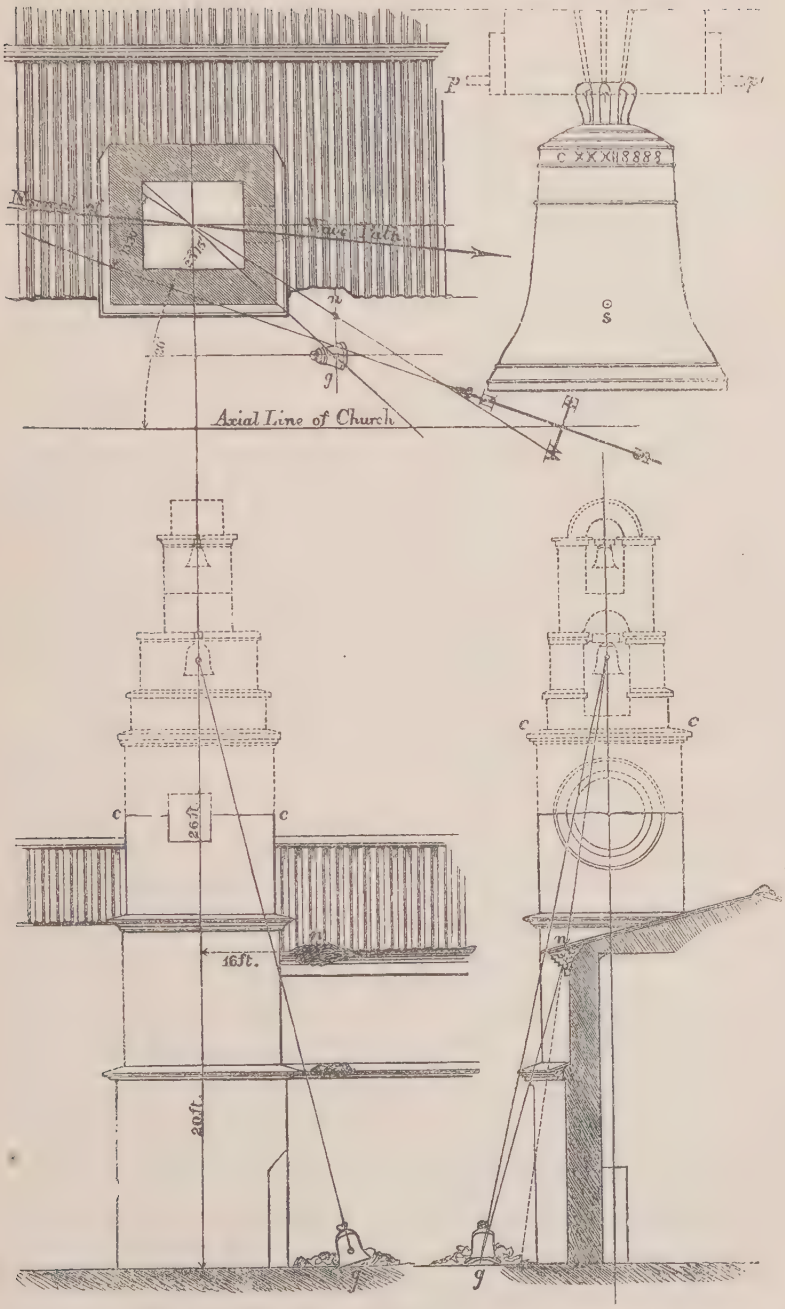
The church of La Sala, like numbers of others in Southern Italy, has been built, not in accordance with ecclesiological notions, but to suit the lie of the ground. Its axial line is 20° W. of north, and it has a campanile, rectangular in plan, external to one flank wall, as in diagram Fig. 206. The upper part of this, previous to the earthquake, carried two bells, hung between the jambs of piers and arches on top. These were overthrown, down to the level of *c c* by

the shock, and the tower has since been taken down, to the level of the centre of the mock clock dial. By careful measurements of the standing portion, and by comparison of the taken down pieces, with the sketches and description of the Sotto Intendente, I was able to restore the design of the superstructure, and obtain a close approximation to its original height. Both bells oscillated in a plane, parallel to the axial line of the church. At the shock, whose wave-path passed obliquely through the open arches on the summit of the campanile, the jambs or side piers separated enough from each other, to permit the bells to be released from their pintles, and these were thrown to the ground, in the direction shown in Fig. 206. The larger bell remained unbroken, having fallen amidst some rubbish on the ground; the smaller was destroyed, having descended from a greater height and fallen on hard ground. The piers did not come down at once with the bells, but fell shortly after. The place where the smaller bell struck the ground, could not be ascertained with certainty, but the Padre, the Sotto Intendente, and others, were agreed upon, and pointed out precisely, the spot where the large bell had alighted; and its path of descent was also indicated by the breaches, which it had made in falling, in the cave tiles of the roof, and in those of a string course of the external flank wall of the church, near the campanile. The bell itself had been removed into the church (but the fallen rubbish was still on the ground): it is very antique and remarkable for its form, and is correctly sketched in Fig. 206, No. 2. It bears an inscription in Lombardic (?) characters, and a date which I presume to be 1324 or 1336. The Padre, who is accustomed to judge of the weight of bells,

It was also observable from the scratches, &c., on the bell, that the eastern pintle had given way first, so that the full force of the shock had not acted in projecting it. The shock acting at the centre of gravity s (No. 2), and the resistance of the last held pintle p, had caused the bell to rotate slightly before falling, and given it along with its glancing off the eave tiles, a much more westerly direction of descent, than was due to the direction of wave-path alone. Both these extraneous forces also had reduced the horizontal distance to which it would have been thrown, had it freely pitched to the ground in its original path—both pintles being freed together.

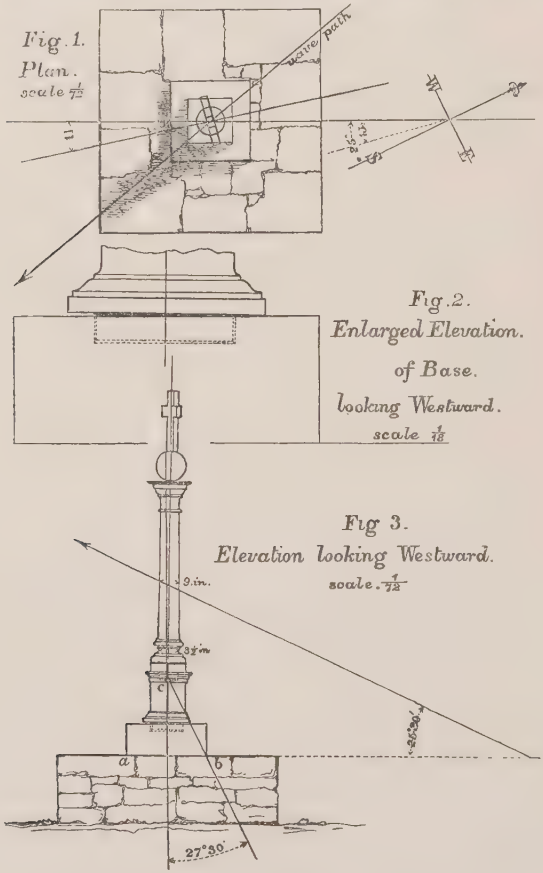
Fig. 216.

cross, and placed upon a square pedestal and plinth block, elevated on a few courses of rude masonry as in Photog. No. 215 (Coll. Roy. Soc.), and Figs. 1, 2, and 3, Diagram No. 216. The ball and cross are secured to the top of the column, only by an iron dowal, and are loose; the plane of

the cross has been long twisted out of square, I was informed.

as in Fig. 2, and jammed quite close to the plinth block at the opposite or north side. The shaft, pedestal, and plinth are socketed into each other, as shown, without cement.

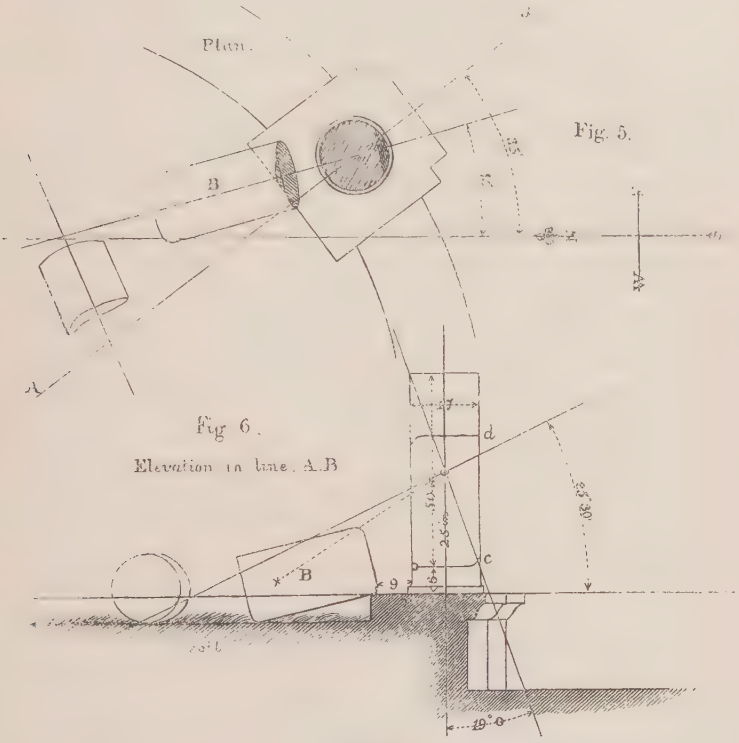
Diagram 221.

The columns had all been originally formed of an artificial "beton" or concrete, of broken limestone and brick, and lime mortar, rudely formed enough, without any base moulding but a fillet, and were 17 inches diameter. They stood upon the top course of a continuous base of limestone, running round a large circular raised platform of earth. They had all been broken down and the shafts had disappeared to within a few inches of their bases years since, except this one portion of a shaft, which stood before the earthquake 4 feet 8 inches above its base. For 6 inches in height the shaft was a united block, and fast to the stone base; at this height an old fracture had existed, and a portion of shaft, 2 feet 10 inches in length, had stood upon the lower block, having been replaced upon it, and a little fine mortar interposed in the old fracture. In toppling over, at the north side of the column, the arris was broken out, and the diameter in N. and S. direction reduced to $15\frac{1}{2}$ inches, as shown in Figs. 5 and 6, Diagram No. 221. Upon the

been overthrown by the shock, and lay as in Figs. 5 and 6, Diagram 221, and as shown in Photog. No. 217, having never been moved or meddled with, the garden being an enclosure, since the earthquake. The lower and longer block was, at its lower end, within 9 inches of the stump of the shaft. The top block had been thrown over along with the one below it, had separated on striking the ground, at the top part, as the position of the other piece and the lower level of the soil than the stone base (Fig. 6) proved, and had slewed round and rolled a little off. The longer piece remained

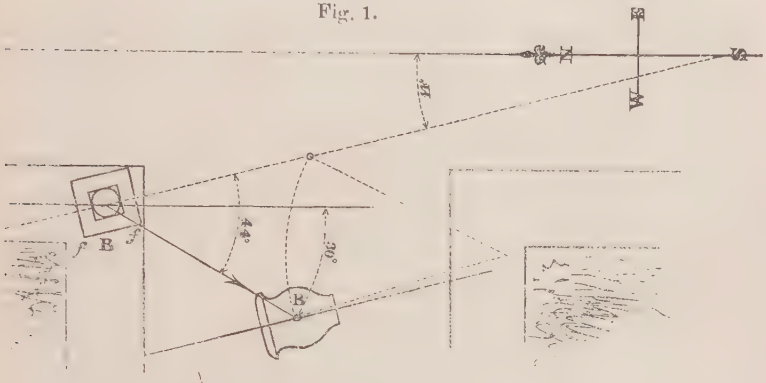
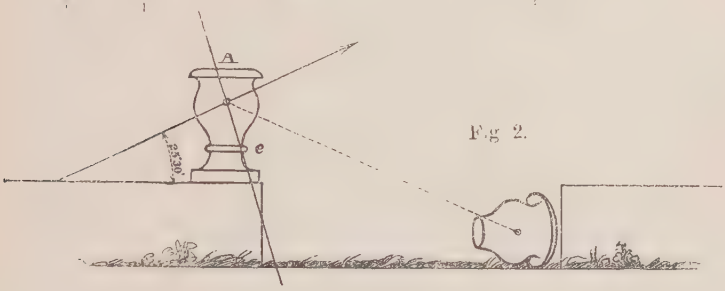
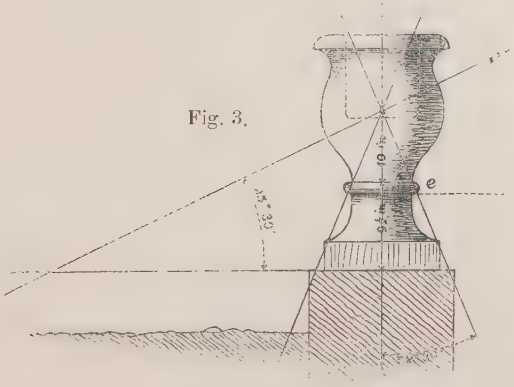
Diagram 222.

The lower portions at the joint *e* (Figs. 1 and 3) were quite

It will be seen, on looking at Fig. 3 (Diagram No. 222), that the vase might have been thus tilted upon its own base at the joint *e*, to the extent of nearly 22° 30′, before it would have lost the power of recovering its position, and that when tilted through part of this angle, the effect of the throw of the second shock delivered to it through the base, would tend to increase the rotation commenced, as well as to diminish the extent of horizontal range, or velocity impressed.

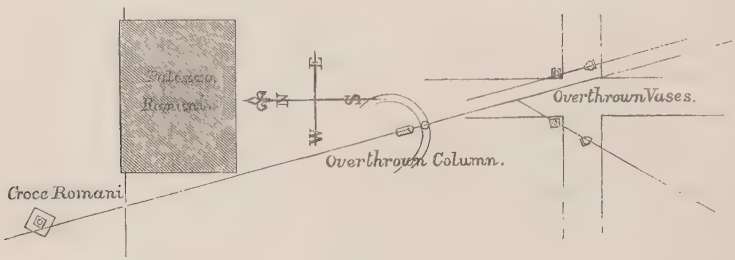
The general relation of all these objects as to azimuth, is shown in Fig. 223.

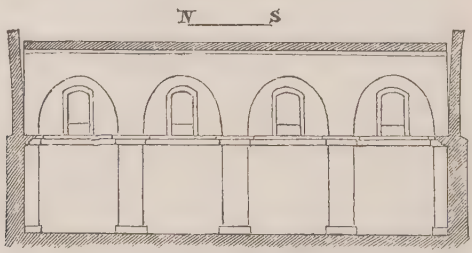
Fig. 239.

To the eastward of the front square, the roofs of the church, and of the grand refectory, groined and arched buildings of great magnitude, have been heavily fissured. In the refectory both end gables, (Fig. 239,) run up originally against the ends of the brick vault, have parted off from it, and pre-

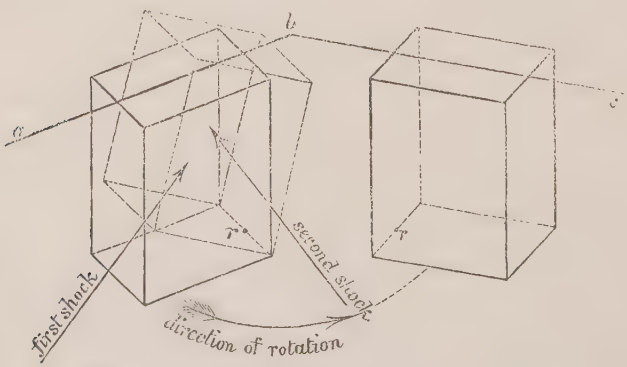
Fig. 235.

Fig. 235 shows the action of any double shock; Fig. 236 the variations of result produced, first, by rotation in the first

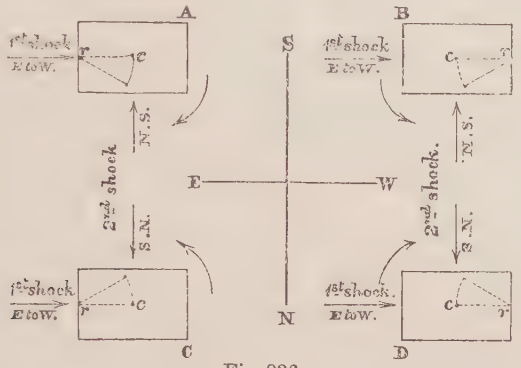
Fig. 236.

semiphase A, and second semiphase B, by the same double shock; secondly, the like by rotation, in the first semiphase (C), the first shock being as before, but the second, contrary in direction to that of the previous cases (A and B), and the like for the second semiphase (D), the two shocks being the same (C and D).

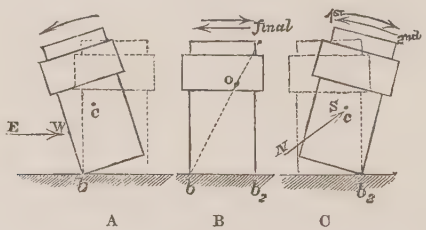
They give us other valuable information, however. In the case of the parallelopipedal chimney, (F. Fig. 1, Diagram Nos. 238-240, and Fig. 4, same diagram), twisted upon its base, it had rotated upon a point in the western edge of its base at *b*, Fig. 237. We know already that the direction (generally) of the first shock, was from some points east or N.E. towards the west or S.W., the second being from 15° W. of north to south. The chimney stalk had therefore made, *one semi*-oscillation, and *one complete* oscillation; that is, it was being acted on by the *second* semiphase of the wave of the *first* shock, at the moment when the second shock arrived at it, as in Fig. 237.

The centre of oscillation of the chimney above *b* thus tilted was, as nearly as could be ascertained, 4·33 feet distant from the edges of the base upon which it tilted *b* and b_2. The first shock, east to west, fractured the chimney from its base, and produced in the detached chimney, one semi-oscillation eastward (A, Fig. 237). The chimney then

relapsed upon its base (B), Fig. 237, and rising again upon the edge b_2, leaned over westward (C), Fig. 237, having thus made one complete oscillation in that direction, with the moment of repose (B), when it had fallen back plumb upon its base. Between that moment of repose, and the completion of the oscillation, or *almost instantly after it had commenced to fall back* (C) from west to east, to reassume its original position of repose, the second shock from the north to south reached it, and twisted it round horizontally, in the manner that has been already explained.

The chimney may be regarded as a parallelopiped vibrating as a compound pendulum, upon b, and b_2 (Fig. 237) as points of suspension, whose centre of oscillation is in the plane of shock passing through the centre of gravity, and distant from b or b_2 by two-thirds of the diagonal of the parallelopiped, in the same plane.

This distance = 4·33 feet is the length of the corresponding simple pendulum, with some small allowances for the hollowness and irregularity of form. The greatest possible arc of vibration, is limited by that which would bring the centre of gravity, c, vertically over b and b_2, Fig. 237, beyond which the mass must have fallen. This I found to be 21°, at either side of the vertical through the centre of gravity, when the chimney was in its original undisturbed state.

From the moment of arrival of the first shock, up to the arrival of the second transverse to it, the chimney had made, one half and one complete, vibration, and possibly had just commenced another. At the moment that the chimney relapsed upon its base it lost *vis vivâ*, and therefore *time*, before it rose again, to complete the arc westward This minute loss of time we can only estimate, because although we know the velocity at the moment the mass of the chimney struck its base, on resuming the perpendicular (B, Fig. 237), we do not know its hardness, elasticity, &c., upon which that loss also depends.

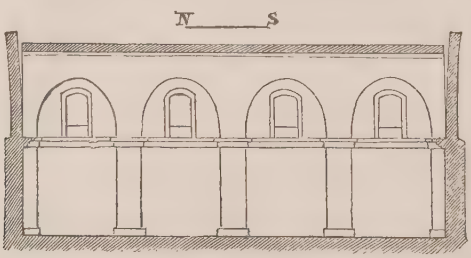
Fig. 239.

The gables were great semicircular walls of rubble stonework, run up from the chord-line or level of the springing, after the vault had been turned, and merely closed in against the ends of the arch, as in Fig. 239, not being bonded into it. Each of these gable walls had gone out at top from the end of the vault, producing a gradually widening and tremendous fissure, which, at the north end, was open 5 inches at top, and at the opposite, or south end, 3 to $3\frac{1}{2}$ inches.

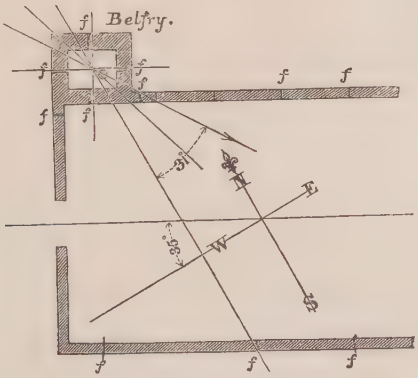
Fig. 250.

The old church, however, gave better results. It was a building of great antiquity; the axial line was 55° W. of north, and, on entering the western door, I observed that two ancient and probably Roman altars, with nearly effaced inscriptions, had been built into the walls, and formed the pedestals for the stone jambs of the doorway. The building has wholly fallen in, and in great part the walls are down. The belfry tower stood at the north quoin (Photog. No. 248), a tower, of about 20 feet square, of which about 47 feet in height remain standing. The whole of the upper part has been thrown down, and the mass has fallen, partly within and partly without the church, and some on the highest remaining floor of the tower itself, all falling towards the S.E. There was a single bell in the tower, of about six cwt., which hung, as the "Parrochiano" (an aged priest, who politely came out in the rain to give me information, and whose name, I regret to find, I omitted to note) informed me, to a beam in the centre of the tower, and at

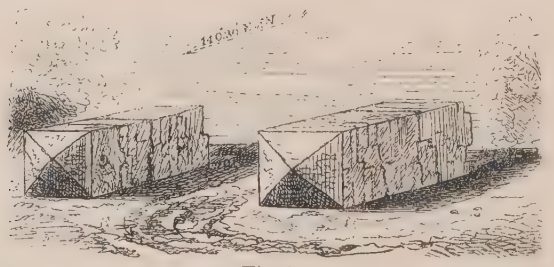
Fig. 257.

About half a mile S.E. of Saponara, upon the level clays of the piano, I passed two square gate-piers of rubble ashlar masonry, leading to an orchard, 3 feet square, and 7 feet in height, both prostrated, and in directions accurately parallel, 140° 30′ E. of north, fractured at the ground level from their foundations. The mortar was bad, and by examination with the hand I judged had not an adhesion
